# The robustness of reinforced concrete tied arch bridges: A case study

arch bridge, corrosion, push-down analysis, reinforced concrete, robustness

The SS 115 road, which connects Trapani with Syracuse passing through Agrigento, crosses the Cassibile river near the municipality with a reinforced concrete tied arch bridge with eliminated thrusts (Figure 4a,b).

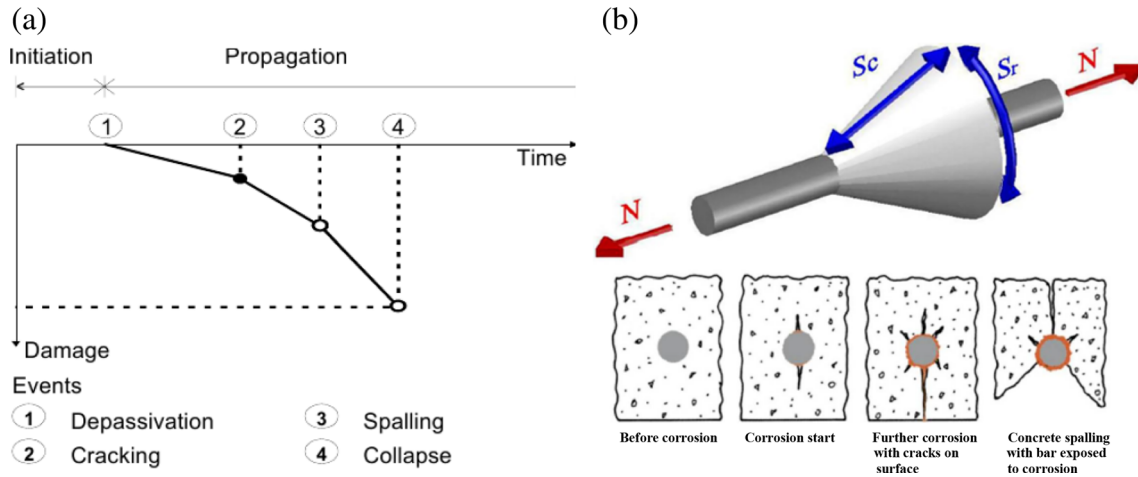
FIGURE 1 (a) Schematic representation of degradation as a function of damage; (b) cover ejection, splitting and spalling failure.<sup>1</sup>

When the passivity conditions cease to exist, the corrosive process of the reinforcement bars, which is of an electrochemical nature, can take place if the concrete meets water and oxygen. The ignition and propagation phases involve the following sub-phases (Figure 1a,b):

- First propagation phase (cracking) up to  $t = t_{(2)} = t_{cr1}$ , where the first crack occurs in the concrete surface due to the reinforcement corrosion;
- Second propagation phase (spalling), with a higher propagation speed due to the presence of cracks, up to  $t = t_{(3)} = t_{cr2}$ , when the operation limit state is no longer satisfied with the concrete spalling;
- Last propagation phase (collapse), denoted by  $t = t_{(4)} = t_u$ , when the resistance reduction is such that the demands imposed by the ultimate limit state are no longer met.

Corrosion leads to the reduction of both the bar cross-section and the elongation capacity of the intact part of the reinforcement bar, with all the negative consequences on structural ductility. Iron oxide (rust), which is the product of the corrosion process, generates a volume larger than that of the basic metal. This produces radial compression stresses ( $S_c$ ) in the concrete surrounding the bar and, for equilibrium, the emergence of circumferential tensile stresses ( $S_r$ ). When these latter pressures reach the concrete tensile strength, the formation of cracks orthogonal to the tensile isostatics occur, usually leading toward the complete expulsion of the cover (spalling failure of Figure 1b).

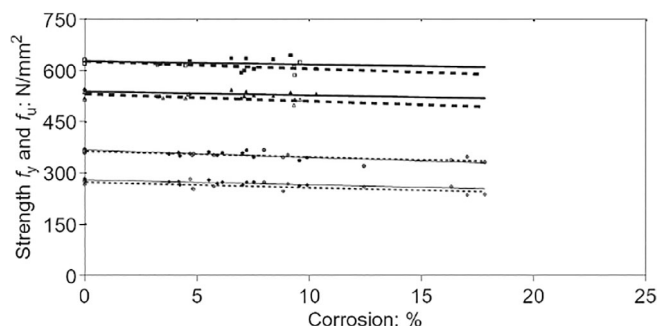
FIGURE 2 Residual resistance of corroded reinforcing bars.<sup>6,7</sup>

The variation of the steel mechanical properties according to the Val et al.'s model<sup>3</sup> can be determined based on the following linear relationship (Figure 2):

$$f = (1 - \beta \cdot Q_{\text{corr}}) \cdot f_0 \quad (1)$$

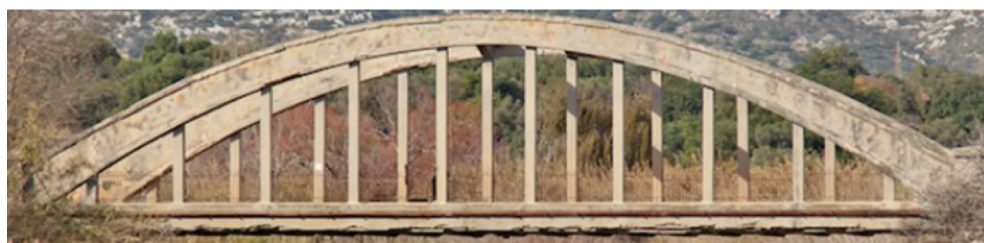
FIGURE 4 Picture and front view of the bridge on the Cassibile river.

The bridge type with eliminated thrust (tied arch type) under study is made of a deck sustained by a couple of overhanging arches through tie-beams. The bridge has a span with length ( $L$ ) of about 30.00 m, with a rise ( $m$ ) of 6.00 m and a hydraulic franc ( $f$ ) of 5.00 m; the pitch ( $p$ ) between arches is 8.30 m, while the roadway width ( $w$ ) is 7.50 m. Therefore, it has a ratio between rise and span equal to 1/5, which represents a typical average value for bridges with eliminated thrust.<sup>9</sup> The superstructure rests on rc piles. The deck consists of a 15 cm thick slab armed with smooth steel bars and is supported by a sequence of beams, which have rectangular cross-section with height of 0.85 m and base of 0.25 m and are alternatively sustained by tie-beams. These beams, having pitch of 1.40 m, have a slightly tapered section at their ends, which are connected to the edge longitudinal beams. Such latter members, fulfilling the task of thrust bearing, also have a rectangular section with a height of 0.85 m and a base equal to 0.50 m. The arches are connected transversely by two  $0.25 \times 0.80$  m beams having the bracing function of the structure. The tie-beams, 10 for each arch, are placed with an interaxis of 2.86 m and have a  $0.36 \times 0.30$  m rectangular cross-section. The road is completed with an original massif and a pavement package that, due to the succession of numerous stretches of bituminous conglomerate, has reached a thickness varying between 0.16 and 0.19 m.

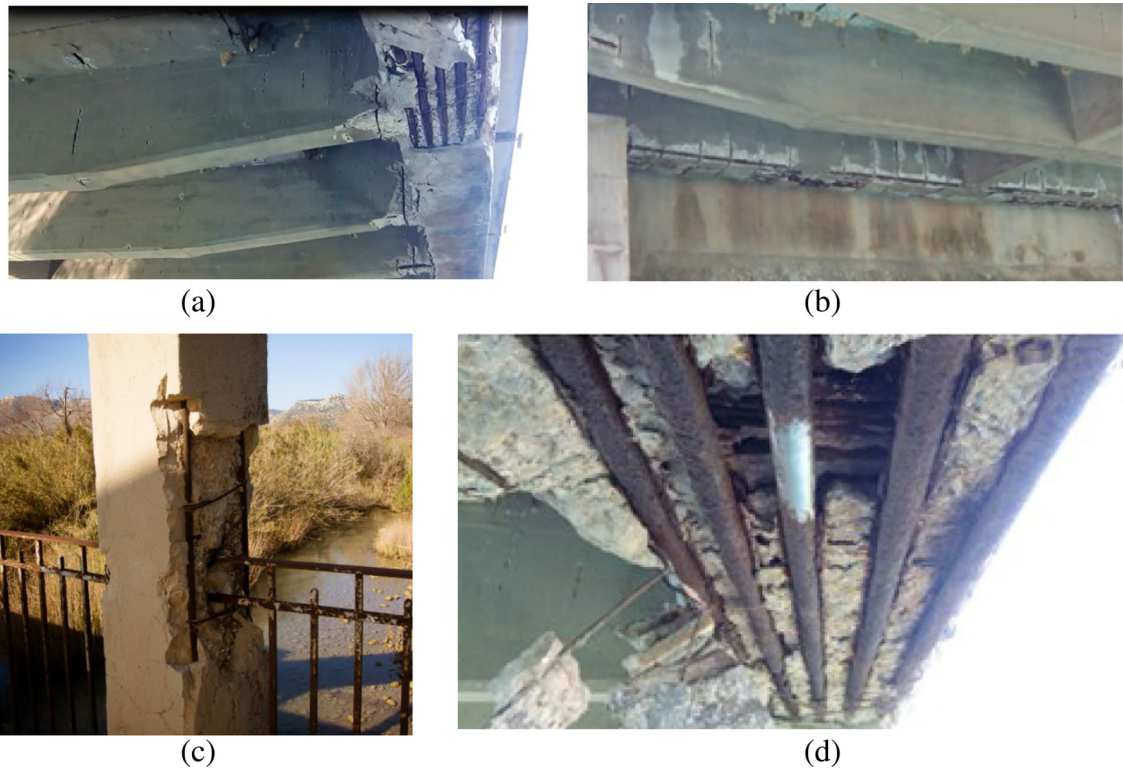
**FIGURE 5** Views of transverse beams (a), longitudinal beams (b) and tie-beams (c) with spalling of concrete cover, corrosion of the longitudinal reinforcement (d) and flaking of the transverse reinforcement.

presented. From the bridge observation, it is apparent that most of the structural elements show an advanced state of degradation, which is manifested by the disintegration or detachment of the concrete cover (Figure 5). In fact, the bridge surfaces showing cover spalling with bars exposed to environmental actions are very extensive. Longitudinal reinforcing bars with diameter of 20 mm do not yet show worrying signs of section reduction, while stirrups are strongly affected by corrosion. The degradation is due to a set of causes, such as the high permeability of the concrete, the aggressive environmental conditions aging on the structure and a prolonged leaching of the bridge lateral and intradosal surfaces due to rainwater coming from the road. Much more information on the health state of the bridge are available in Reference 9.

Signs of a cortical healing operation are detected, but they are considered as inadequate, as shown in the above photographic documentation. The reasons of this insuccess are due to the inadequacy of the mechanical characteristics of the filler material, too rigid compared to the base material and, probably, to the inadequate support preparation before the intervention.

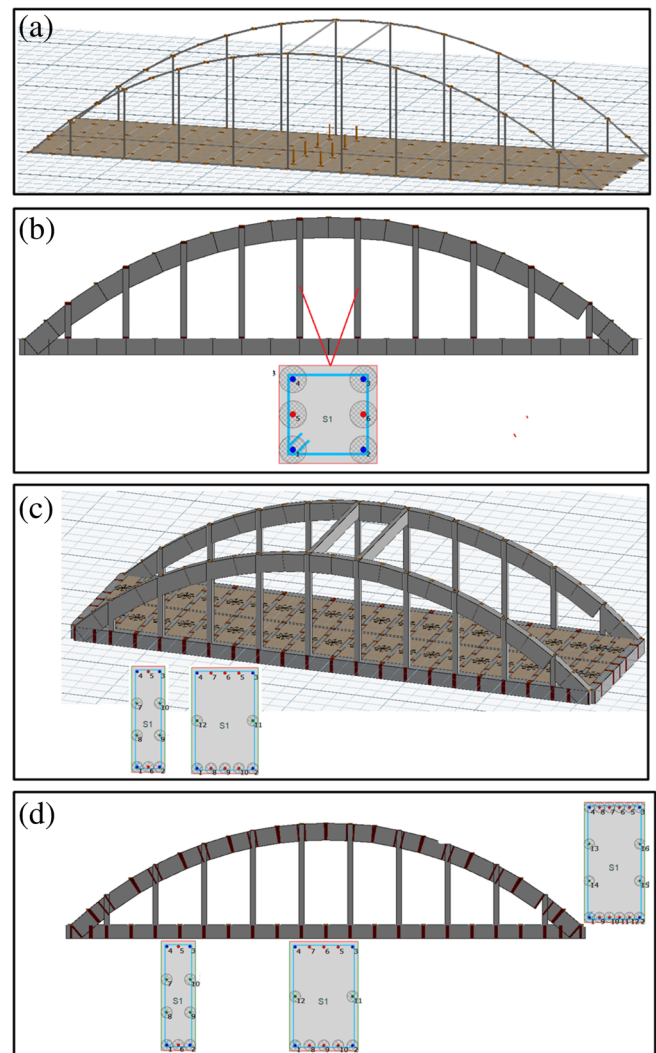
**FIGURE 6** FEM model of the bridge with loads in the middle of the deck (a) and degraded structural models: (b) deterioration scenario I with corrosion of tie-beams ( $x_{\text{corr}} = 1$  and  $R = 3$ ); (c) deterioration scenario II with corrosion of deck beams ( $x_{\text{corr}} = 1$  and  $R = 3$ ); (d) deterioration scenario III with corrosion of deck beams and lateral arches ( $x_{\text{corr}} = 1$  and  $R = 3$ ).

Operatively, after the creation of the bridge FEM model (Figure 6a), to define its ultimate bearing capacity and the related robustness index, reference is made to non-linear models with three embedded corrosion degradation models (Figure 6b–d), in which a non-linear static push-down analysis is performed under displacement control by modifying the control node with the position of the mobile load. This analysis procedure is carried out by the following steps:

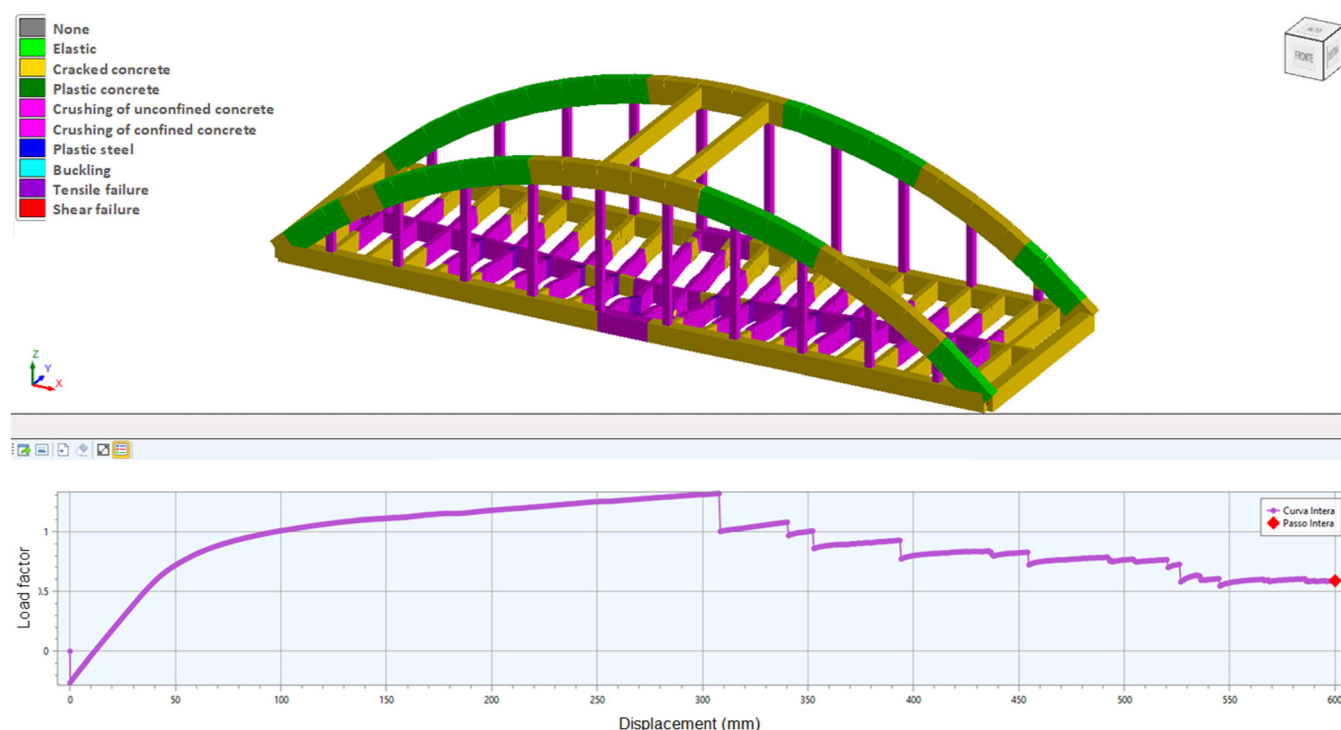
FIGURE 7 Damage state of the real configuration of the bridge.

The damage state of the bridge in the actual configuration is plotted in Figure 7, where it is apparent that the tensile failure of reinforcement beams of both deck longitudinal beams and transverse beam is noticed. On the other hand, the damage state of tie-beams (scenario I) is characterized by the tensile failure of their reinforcement bars and the deck collapse, as shown in Figure 8a. Moreover, in Figure 8b the point of the curve when bars fail is shown and the degraded concrete parts are highlighted in the fiber model of the VSQNEXT calculation code, which is an applicative program of the FATANEXT NL software. In Figure 9a, the robustness index of both the original and degraded bridge is plotted as a function of the mobile loads position. The results show that the degraded bridge has an index about 64% than that of the original state bridge. In Figure 9b, the variation of the robustness index versus both the scenario variation and the considered corrosion level ( $x_{\text{corr}}$  from 0.5 to 3.0 mm) is plotted.

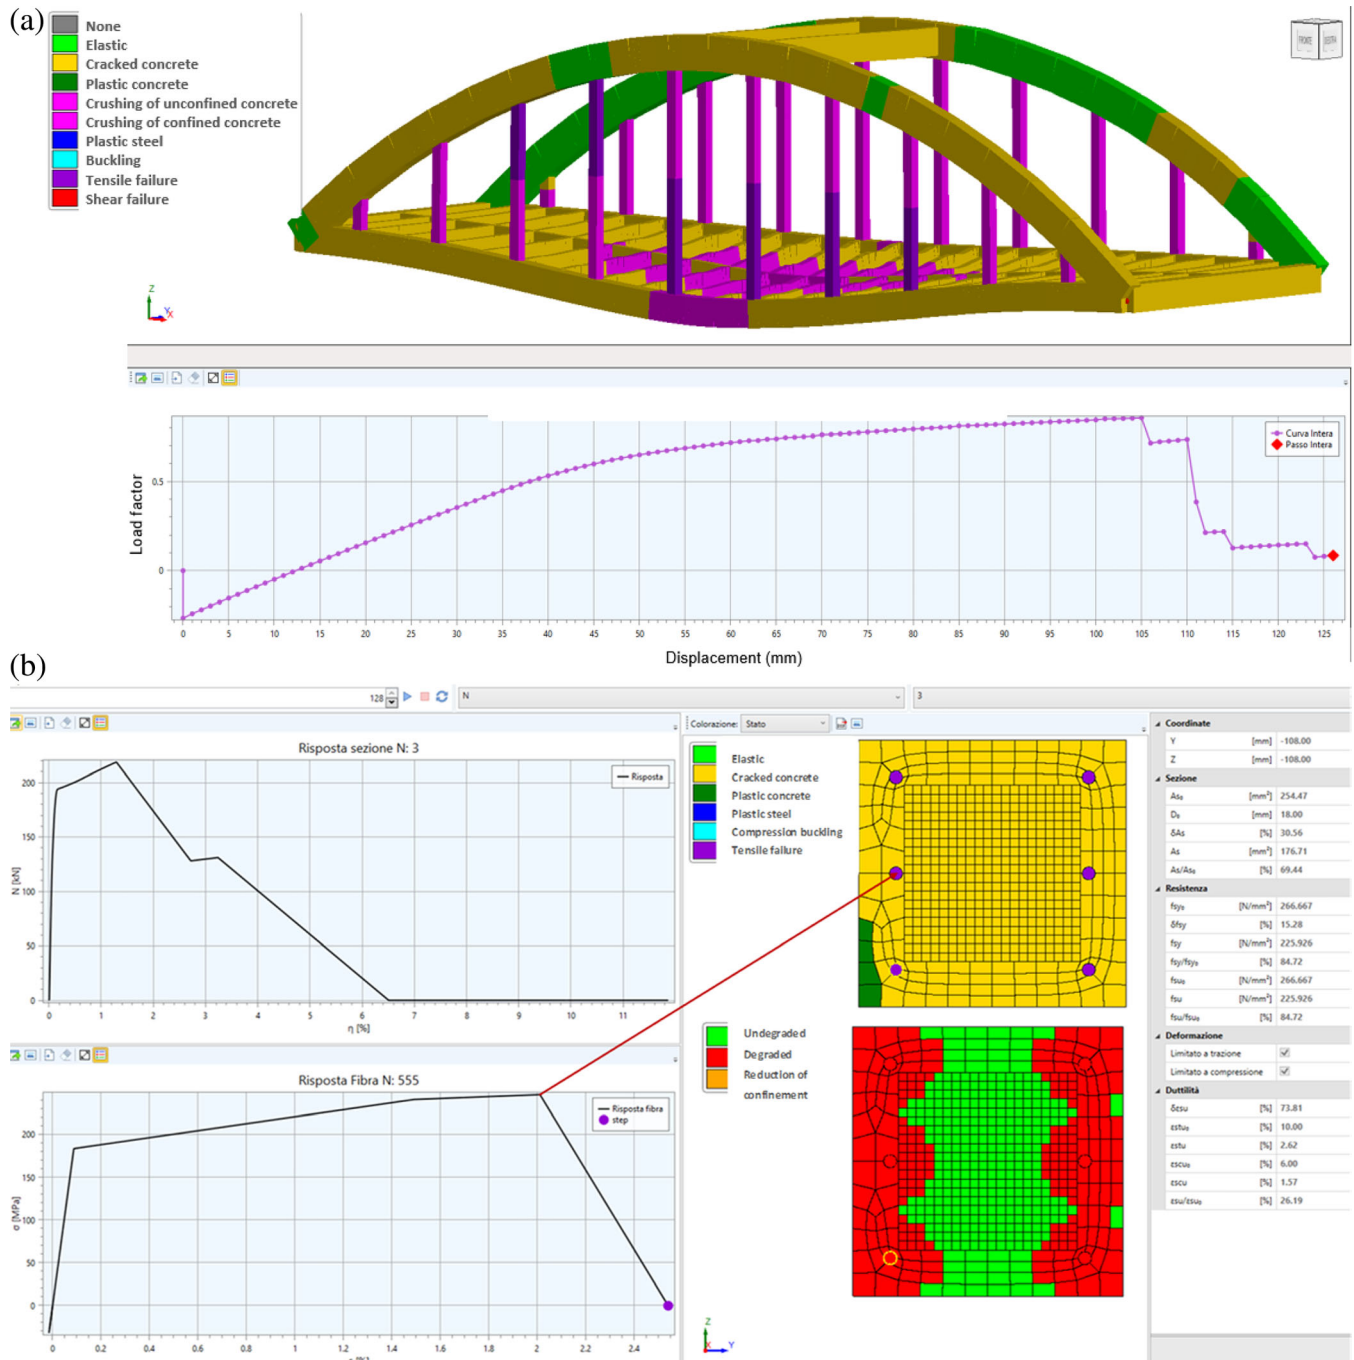
FIGURE 8 Damage state of the degraded configuration of the bridge (a) and details on both the failure of bars and the amount of deteriorated concrete portions of tie-beams (b).

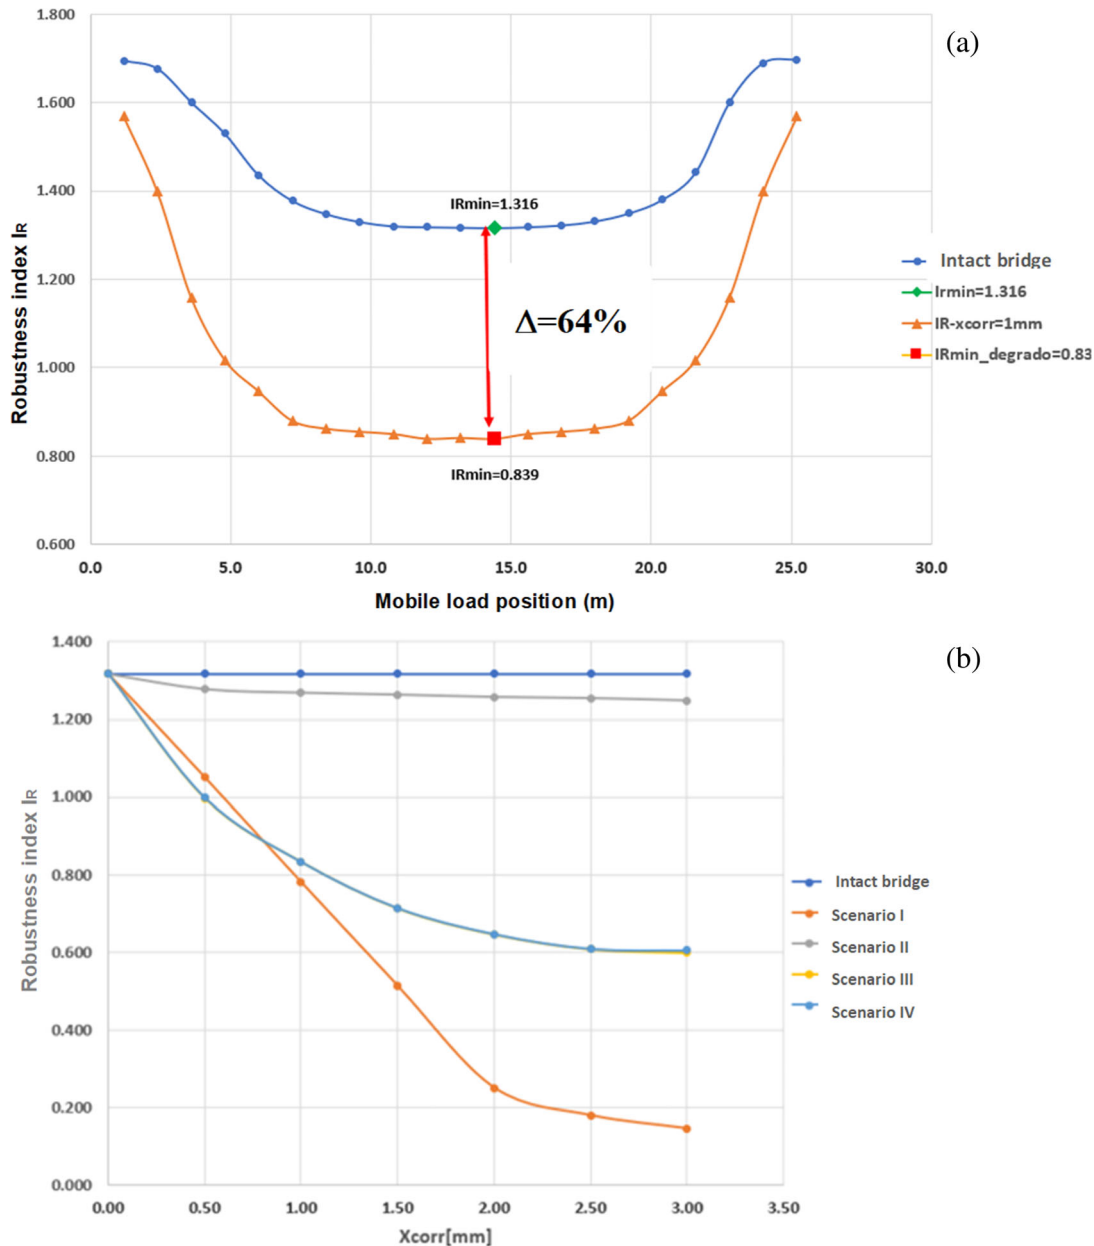
FIGURE 9 Variation of the robustness index versus (a) the position of the mobile loads and (b) the loading scenario and the corrosion depth ( $x_{corr} = 0.5/3.0$  mm).

- The minimum robustness index, which is strongly variable with the position of mobile loads, was determined considering the traffic load critical position, defined as a function of both the scenario and the extent of degradation (corrosion depth between 0.5 and 3.0 mm);
- The critical scenario was attained due to the tensile failure of corroded tie-beams, which induce the structural collapse with a reduction of the robustness index of about 50%–70%;
- The tie-beams played a fundamental role, since they gave to the bridge the right degree of redundancy, as well as the proper connection between the deck and the main arches to have a static scheme with eliminated thrust. When they prematurely collapsed, the arches and the deck were not able to redistribute the
