# **Degrado, Robustezza e Metodi di calcolo per infrastrutture esistenti in calcestruzzo armato**

**VALUTAZIONE DELLA  
CAPACITA' PORTANTE DI UN  
PONTE AD ARCO IN C.A.  
SOGGETTO A VARI SCENARI DI  
DEGRADO**

# The robustness of reinforced concrete tied arch bridges: A case study

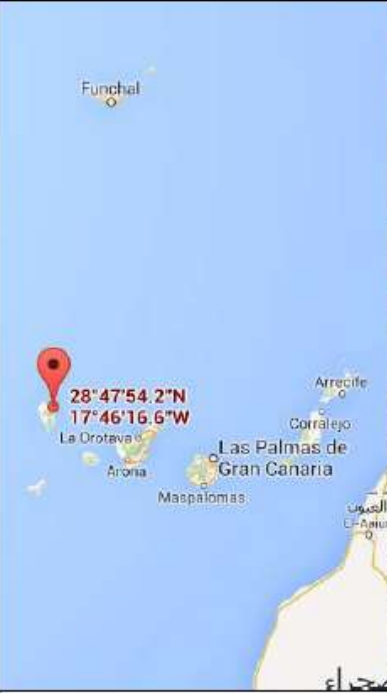
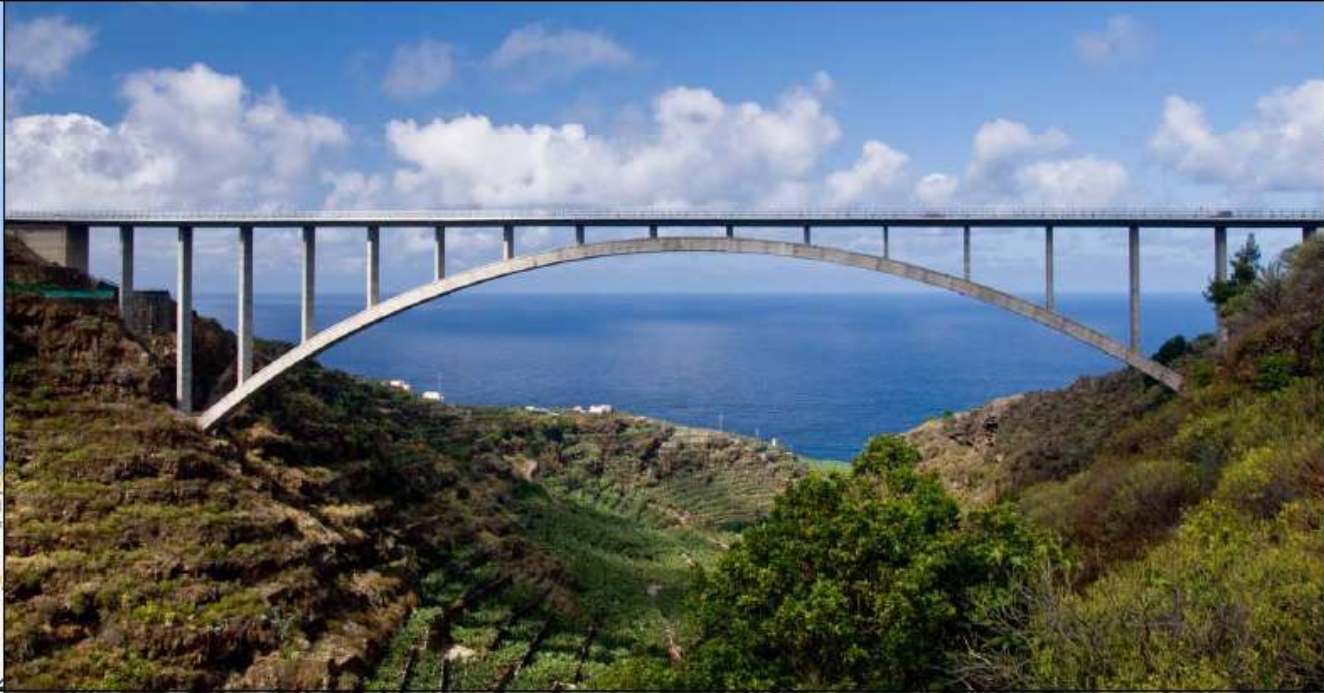
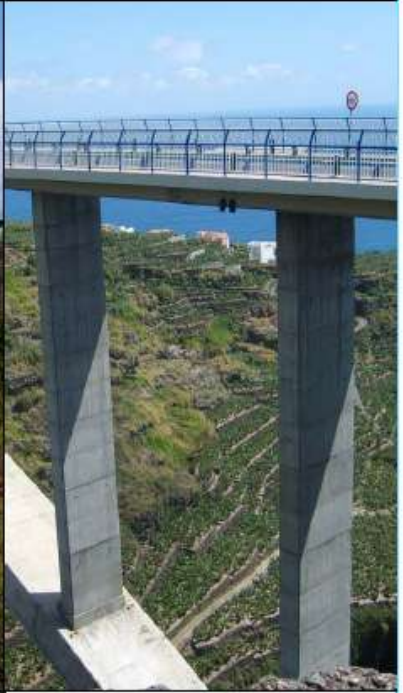
Ponte de Los Tilos, La Palma, isole Canarie (Spagna)

| <p>coordinate<br/>28°47'54.2"N<br/>17°46'16.6"W</p> | <p>Arco di 255 metri di lunghezza</p> | <p>anno<br/>2004</p> |

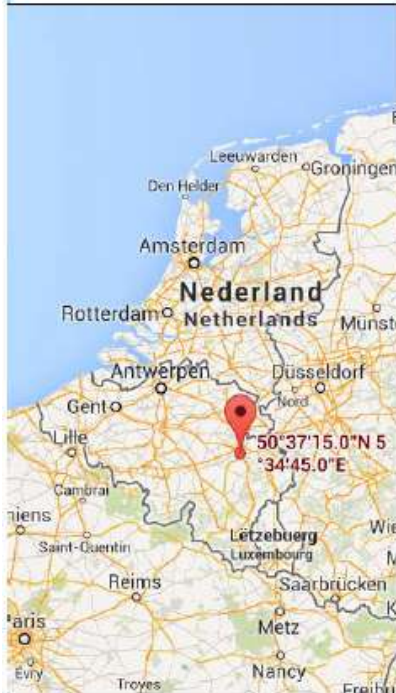
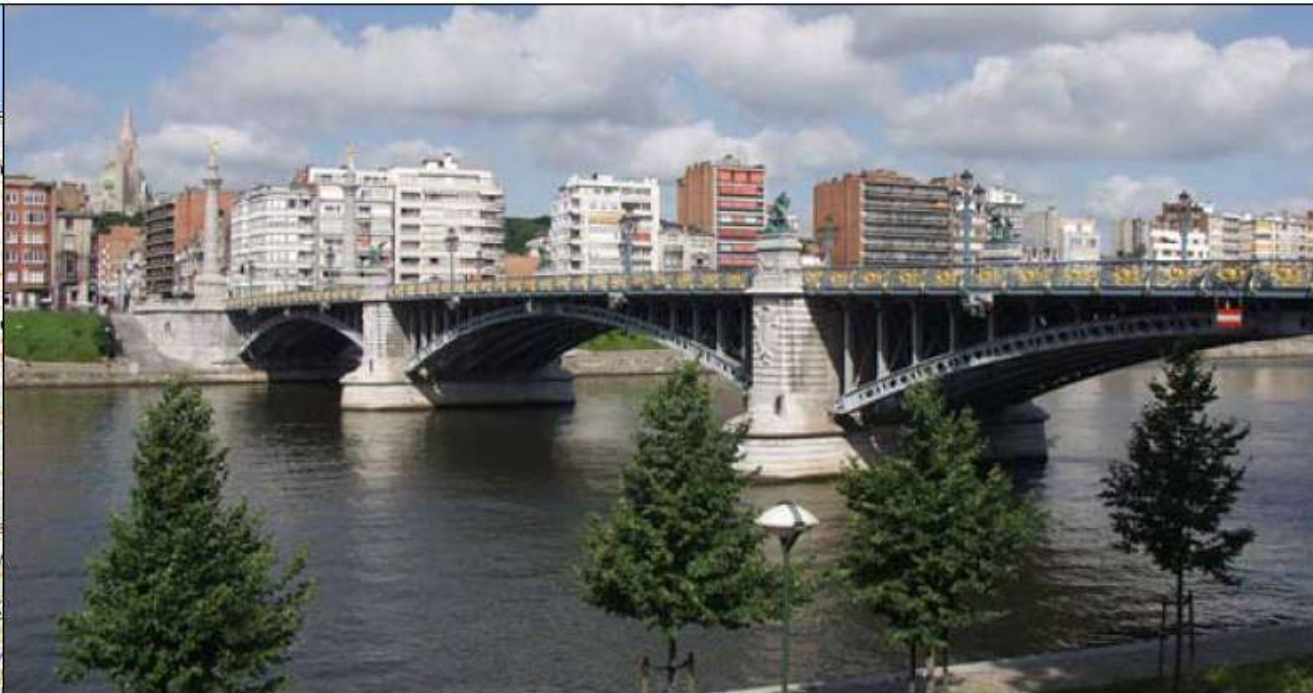
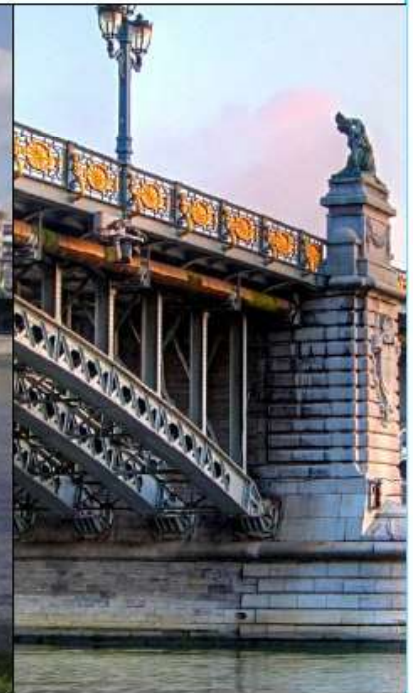
### Ponte di Fragnée sul fiume Meuse a Liegi (Belgio)

Lughezza totale di 177.6 metri.  
Campate 53.725 m - 57.750 m - 53.725 m

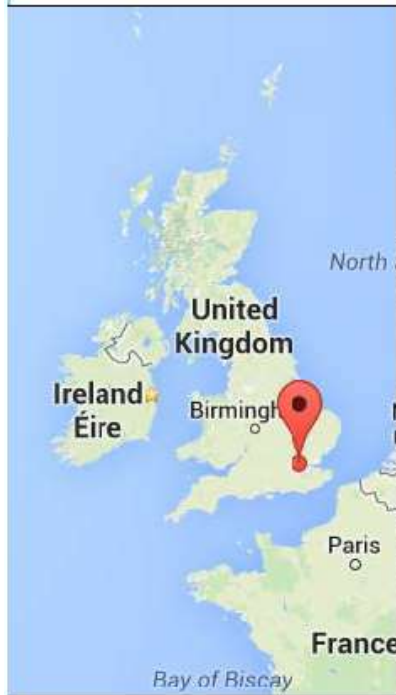
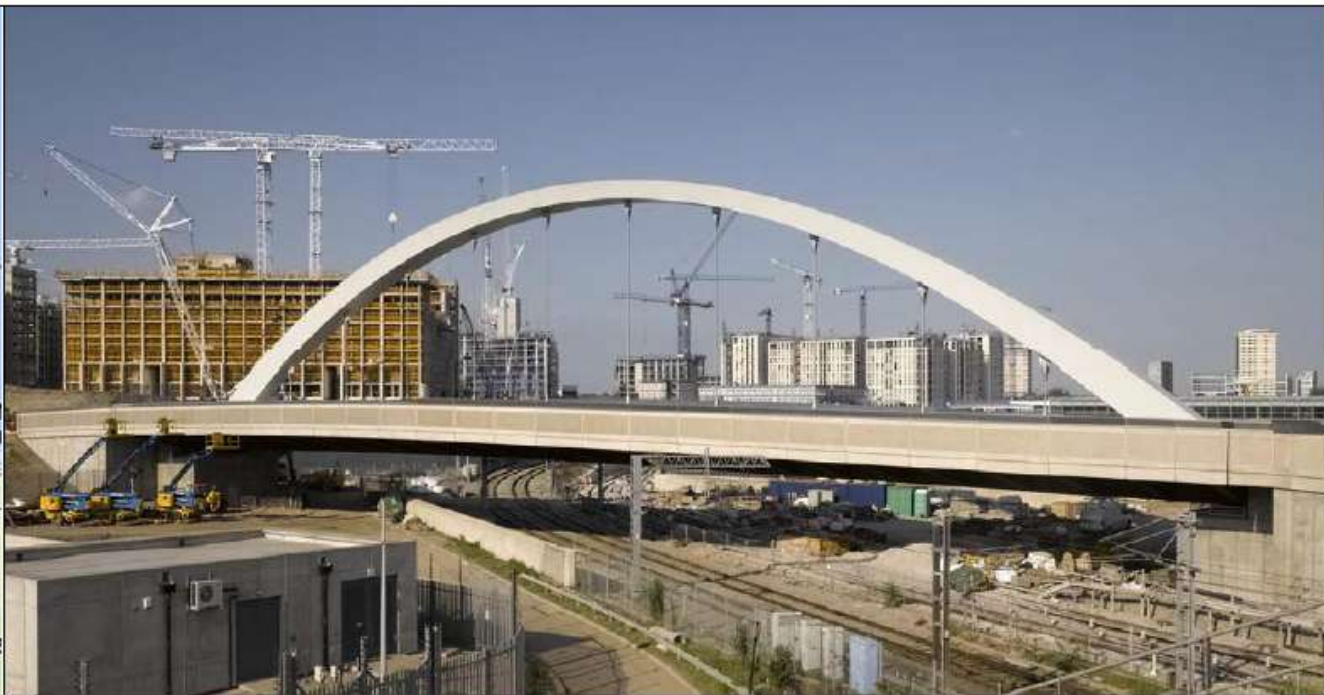
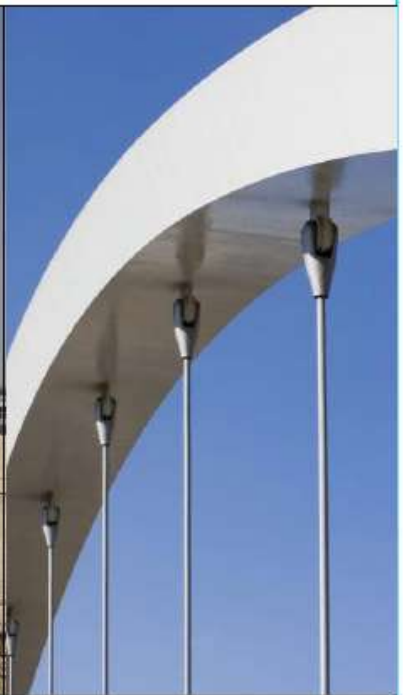
### Bridge 20 a Londra (Inghilterra)

| <p>coordinate</p> <p>51° 32' 41.40" N<br/>0° 0' 45.59" W</p> | <p>Arco di 85 metri di luce</p> | <p>anno</p> <p>2010</p> |

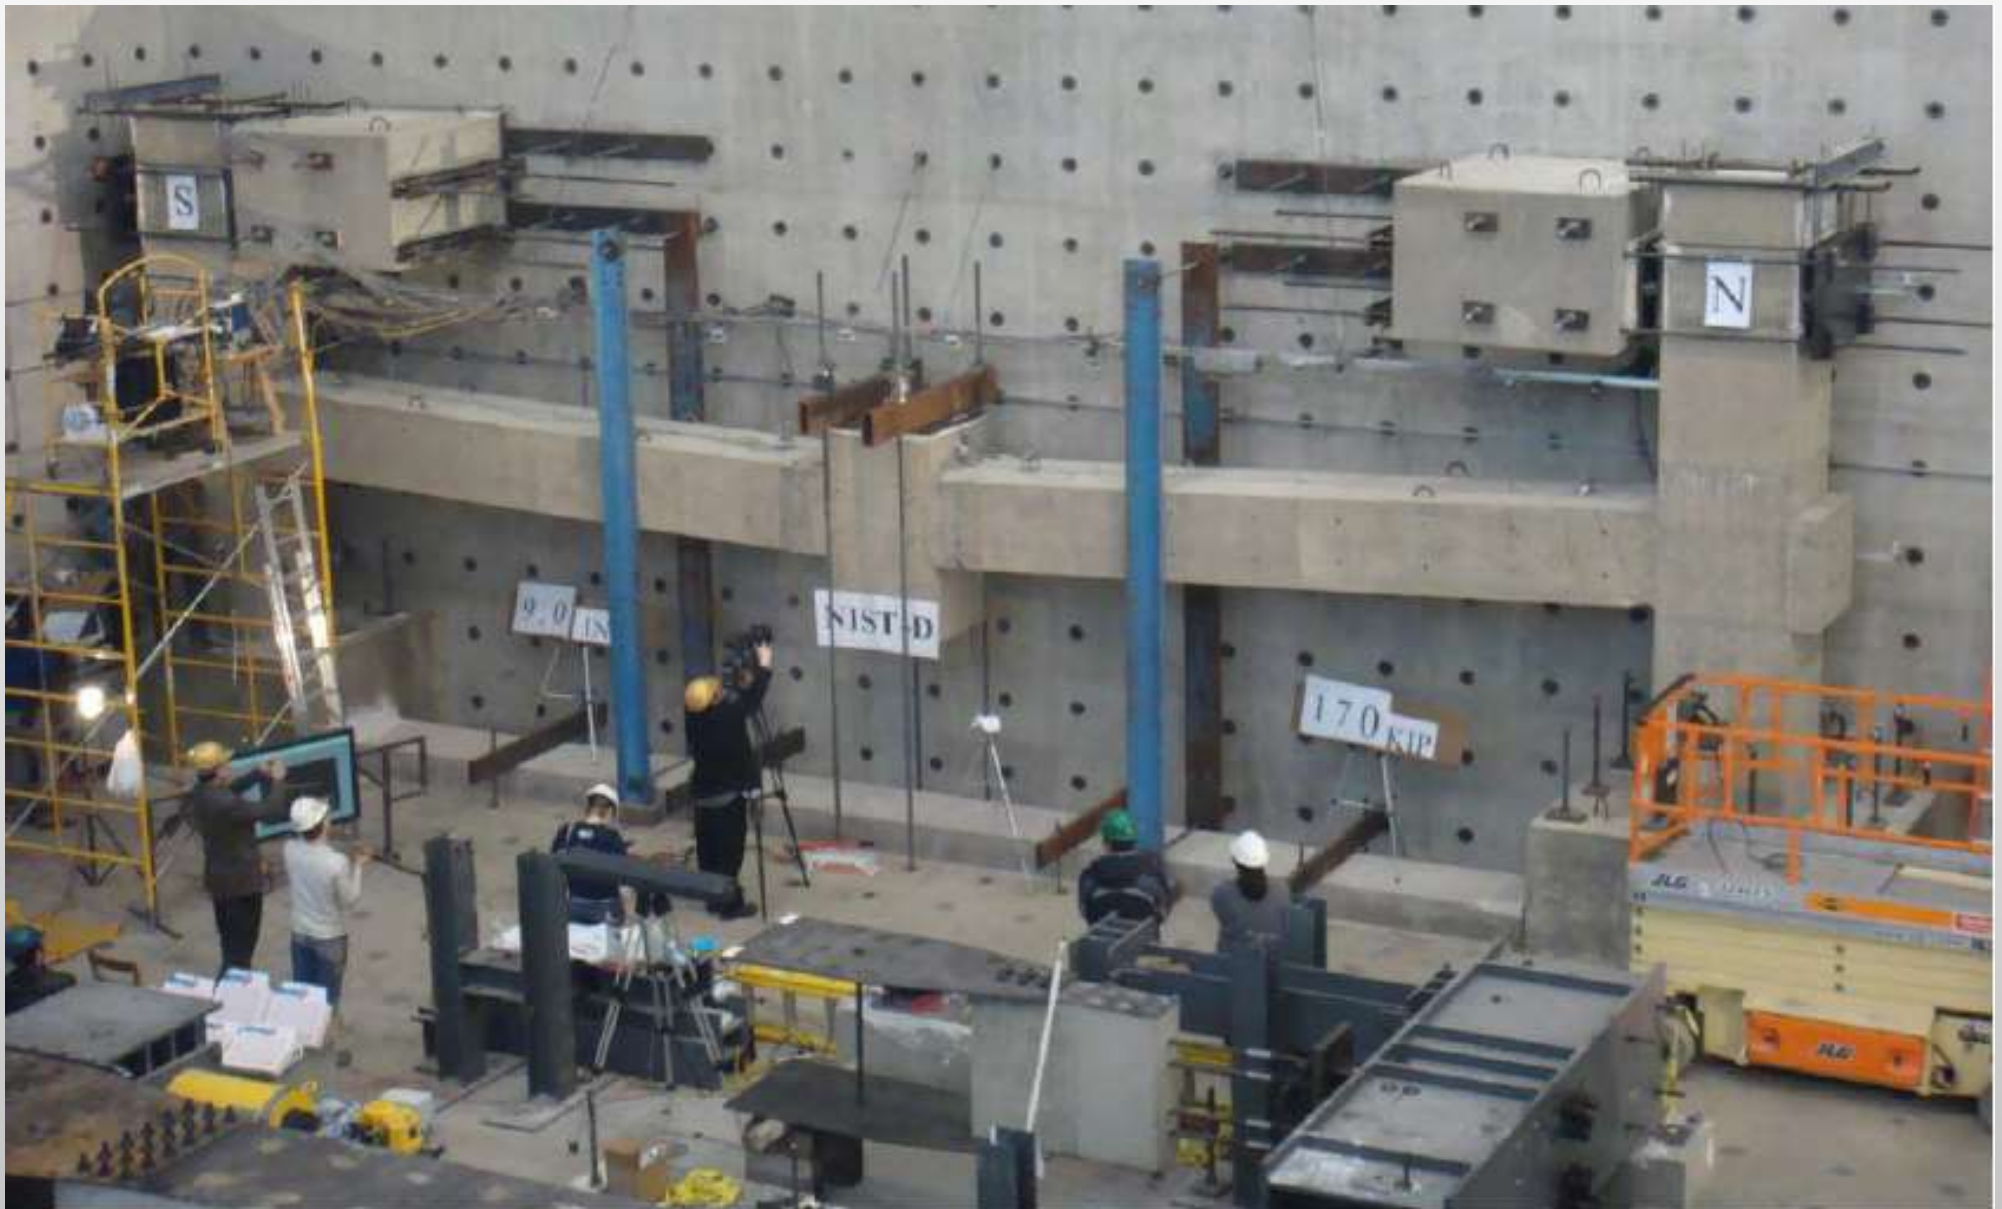
## Prototipo sperimentale (Lew et.al, NIST 2011)

**Modello sperimentale sottoposto a grandi spostamenti (circa 110 cm) e modalità di collasso con rottura dell'armatura longitudinale inferiore del nodo centrale (Lew et.al, NIST 2011)**

**Le analisi effettuate come da test sperimentale prevedono l'applicazione di una forza al centro della trave con intensità pari a 320 kN. Lo stato di danno (ampiezza fessure) e lo spostamento massimo rilevato sono rispettivamente circa 70 mm e 1100 mm.**

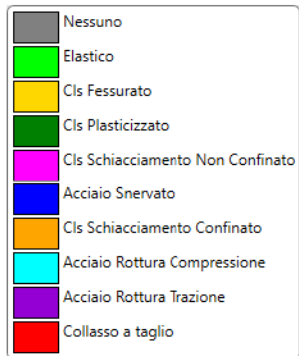
# Effetto arco e catenaria, influenza del degrado: $x_{corr} = 2,50$

## CATENARIA NON SVILUPPATA

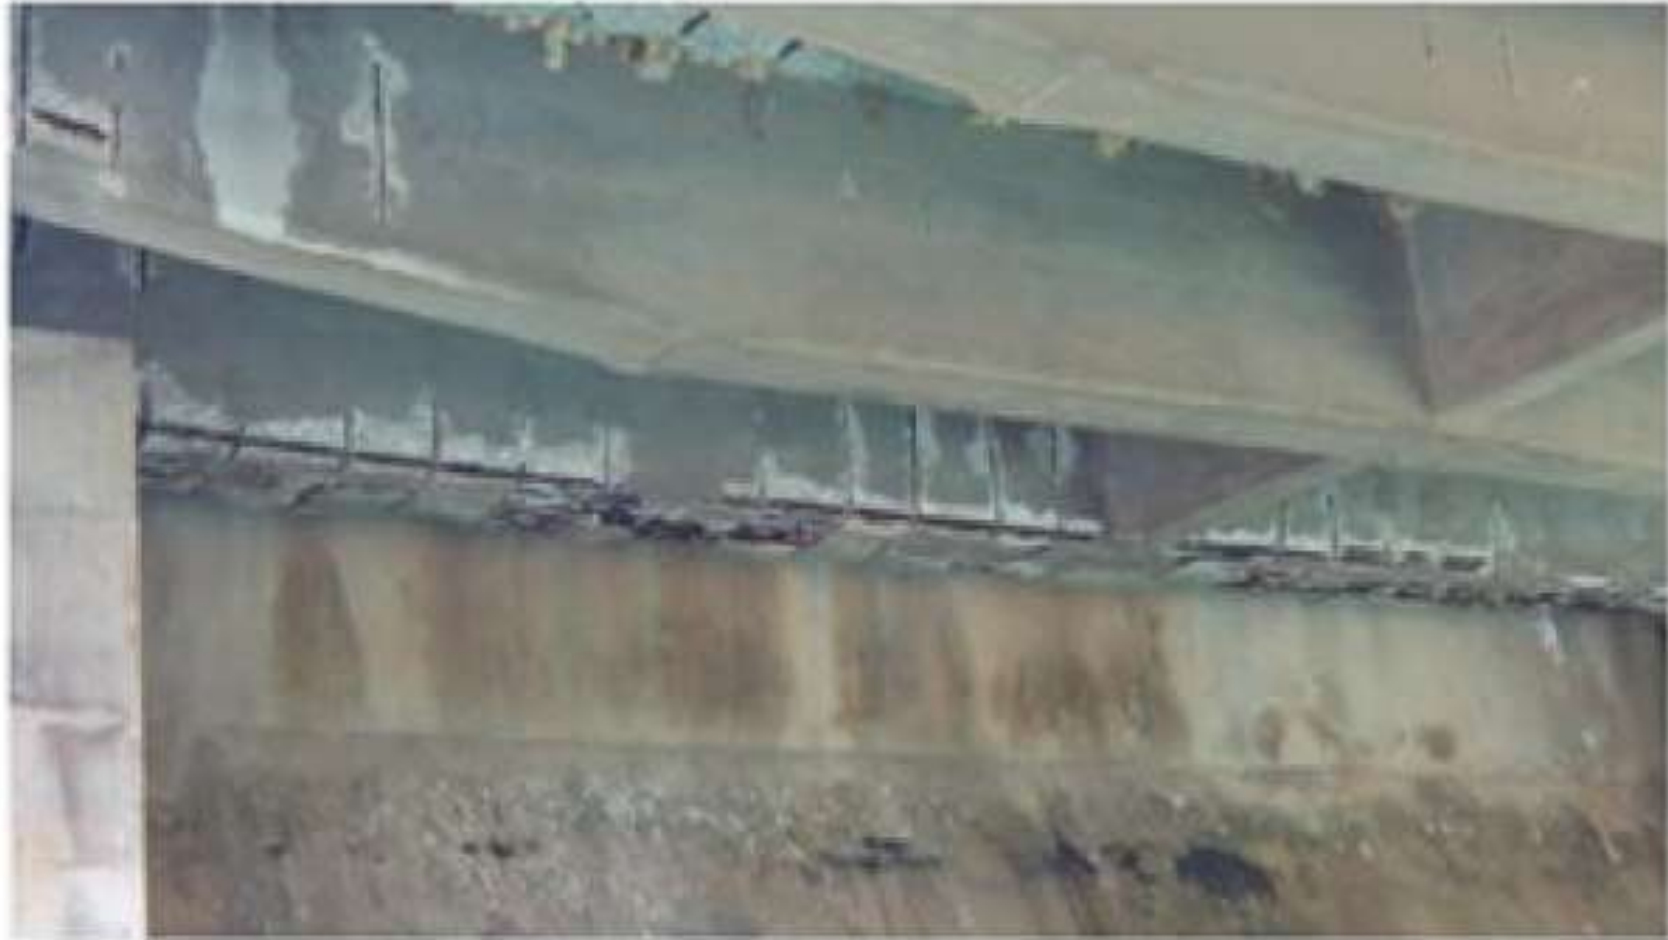
Figure 4. Degradation of cross tested beam with concrete cover spalling and longitudinal and cross bars corrosion /Degrado del traverso di testata con espulsione del copriferro e corrosione delle barre longitudinali e trasversali.

**Gran parte degli elementi strutturali sono in avanzato stato di degrado, con la disgregazione o il distacco dello strato corticale di calcestruzzo. Molto estese sono le superfici in cui le armature sono vista.**

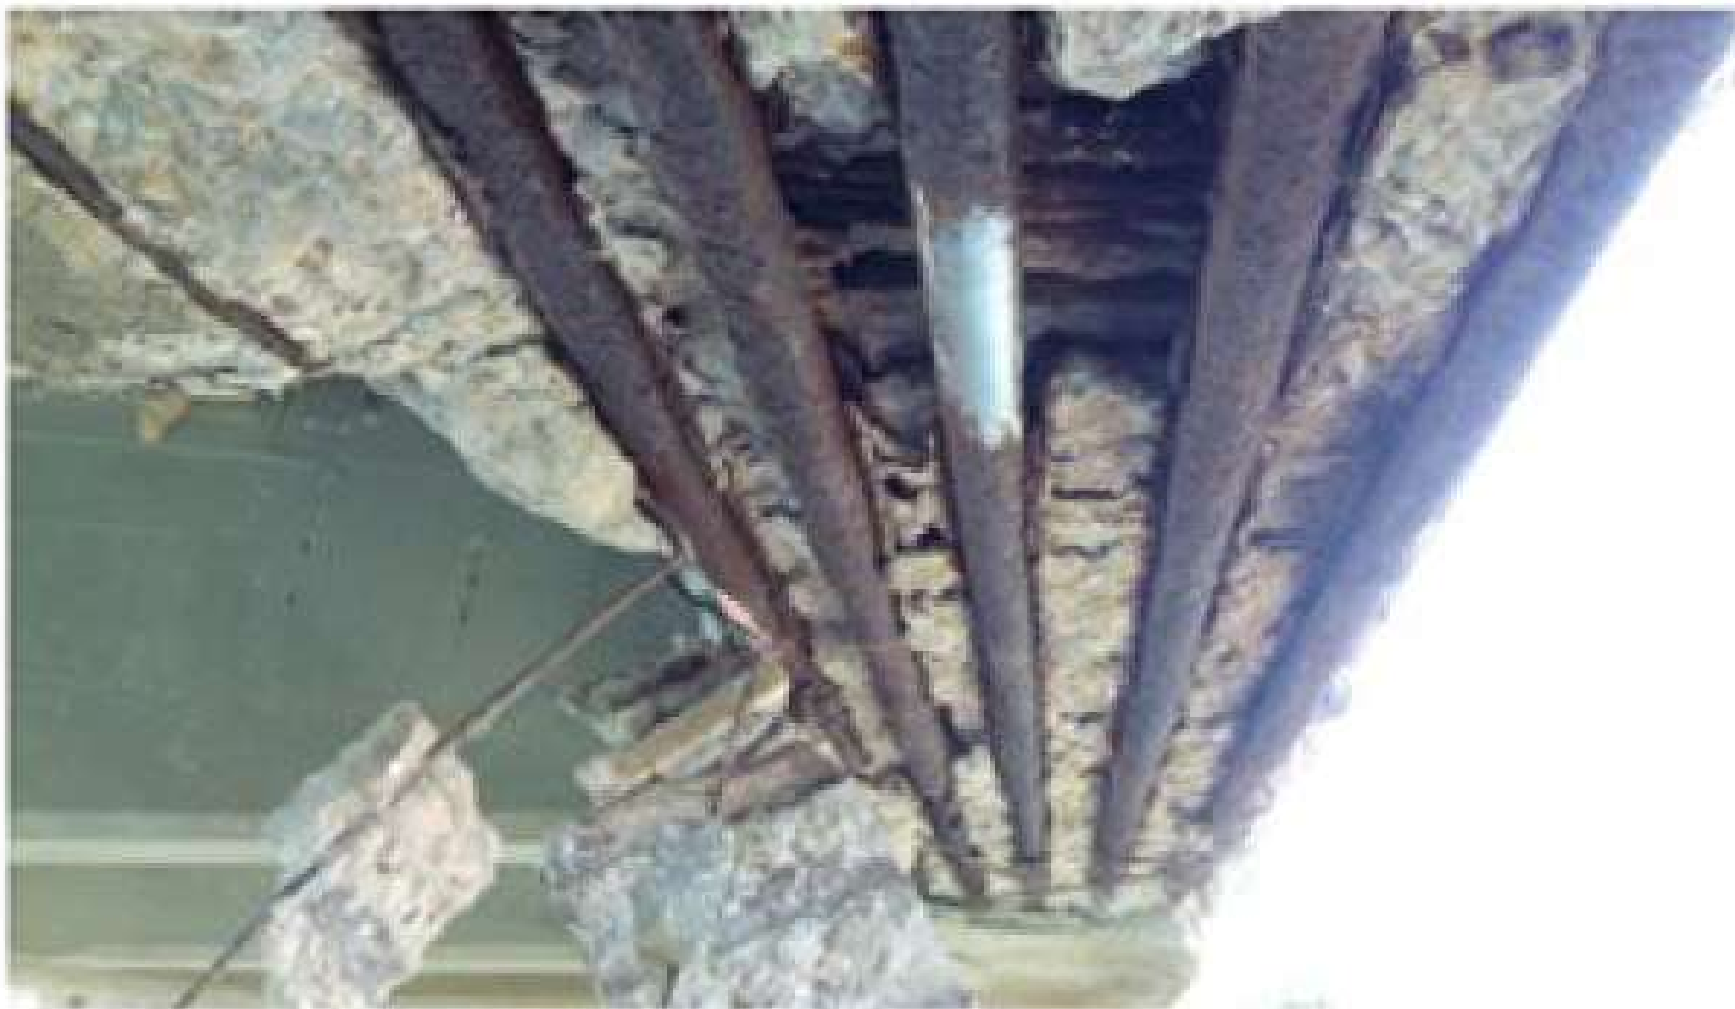
Figure 5. Thrust beam – Concrete cover expulsion, reinforcement corrosion /Trave reggispinta – Espulsione del copriferro, corrosione dell'armatura longitudinale e sfaldamento dell'armatura trasversale

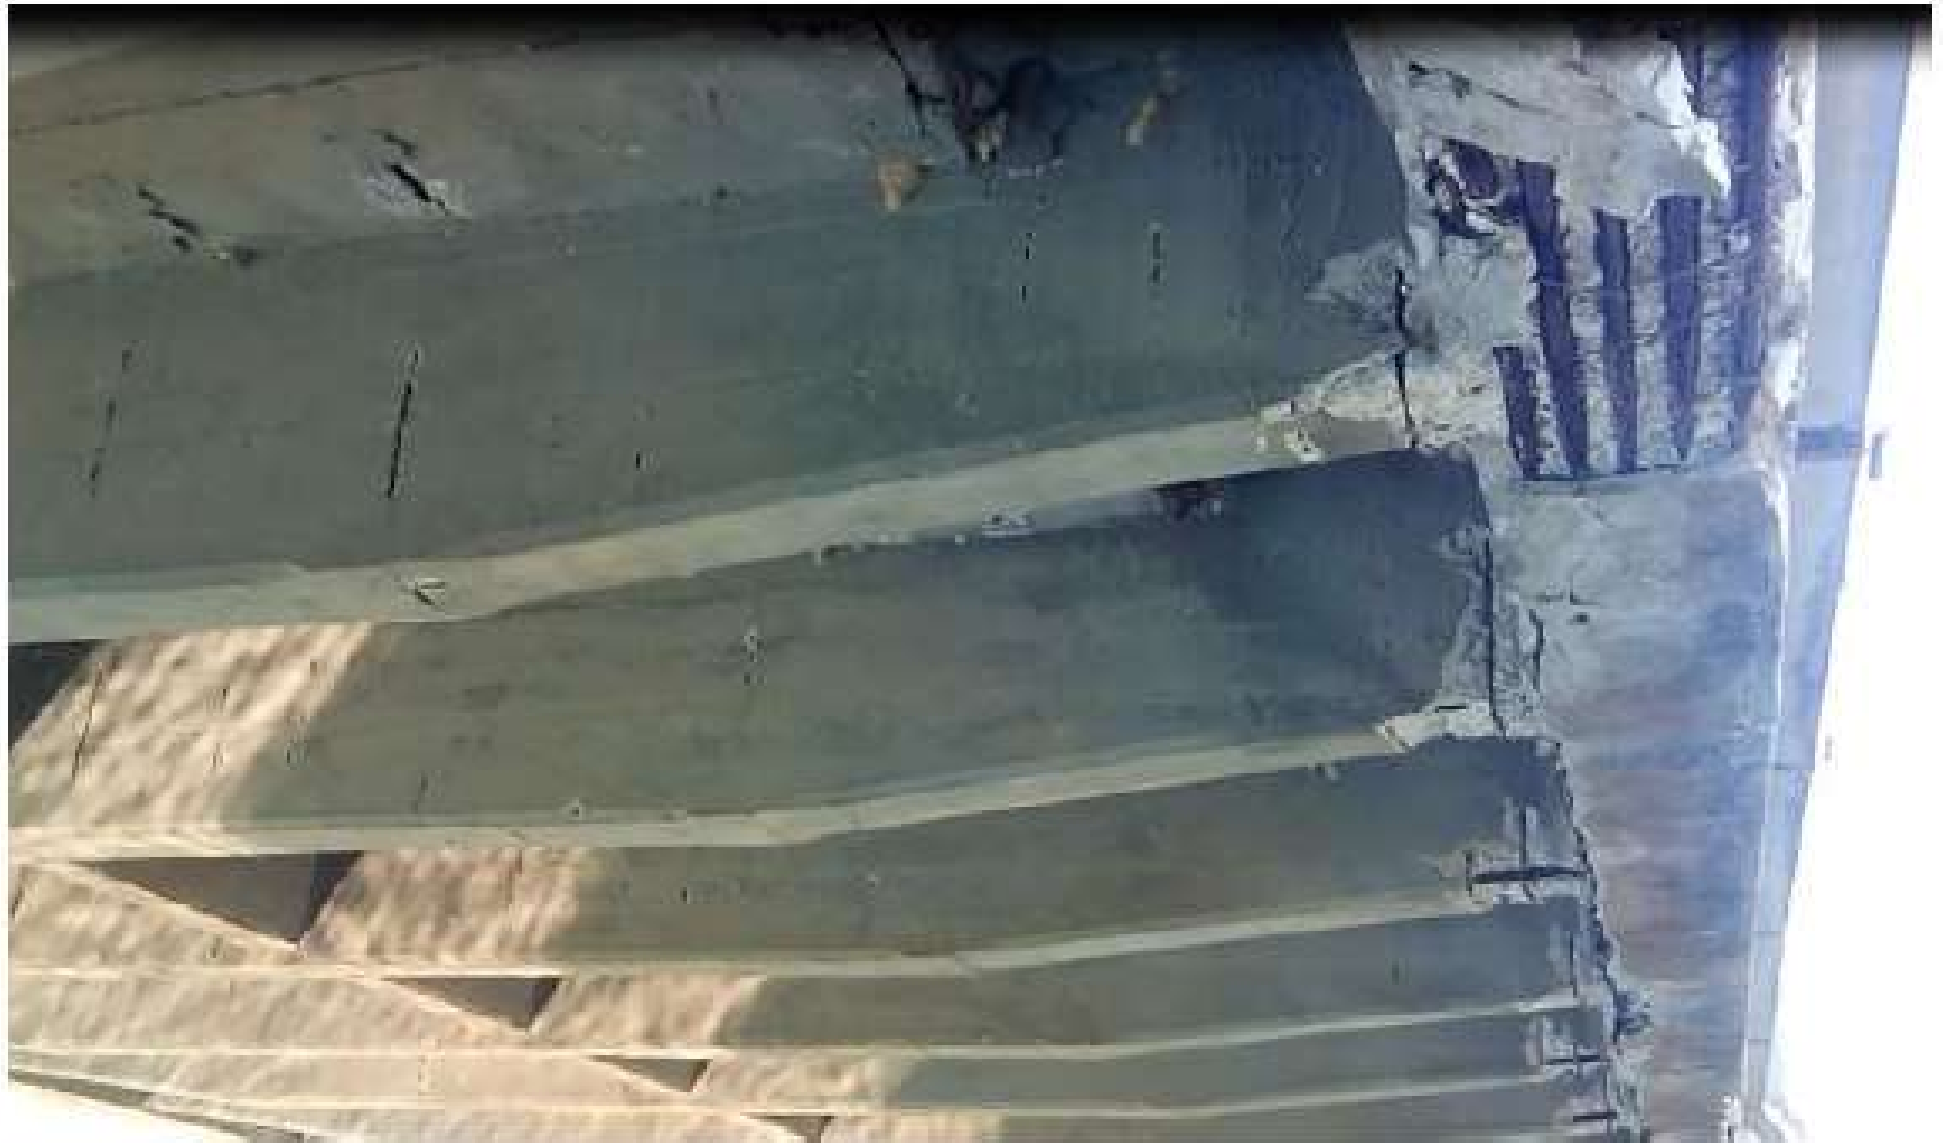
Figure 2 – Cross beam and thrust beam/Traversi e trave reggispinta

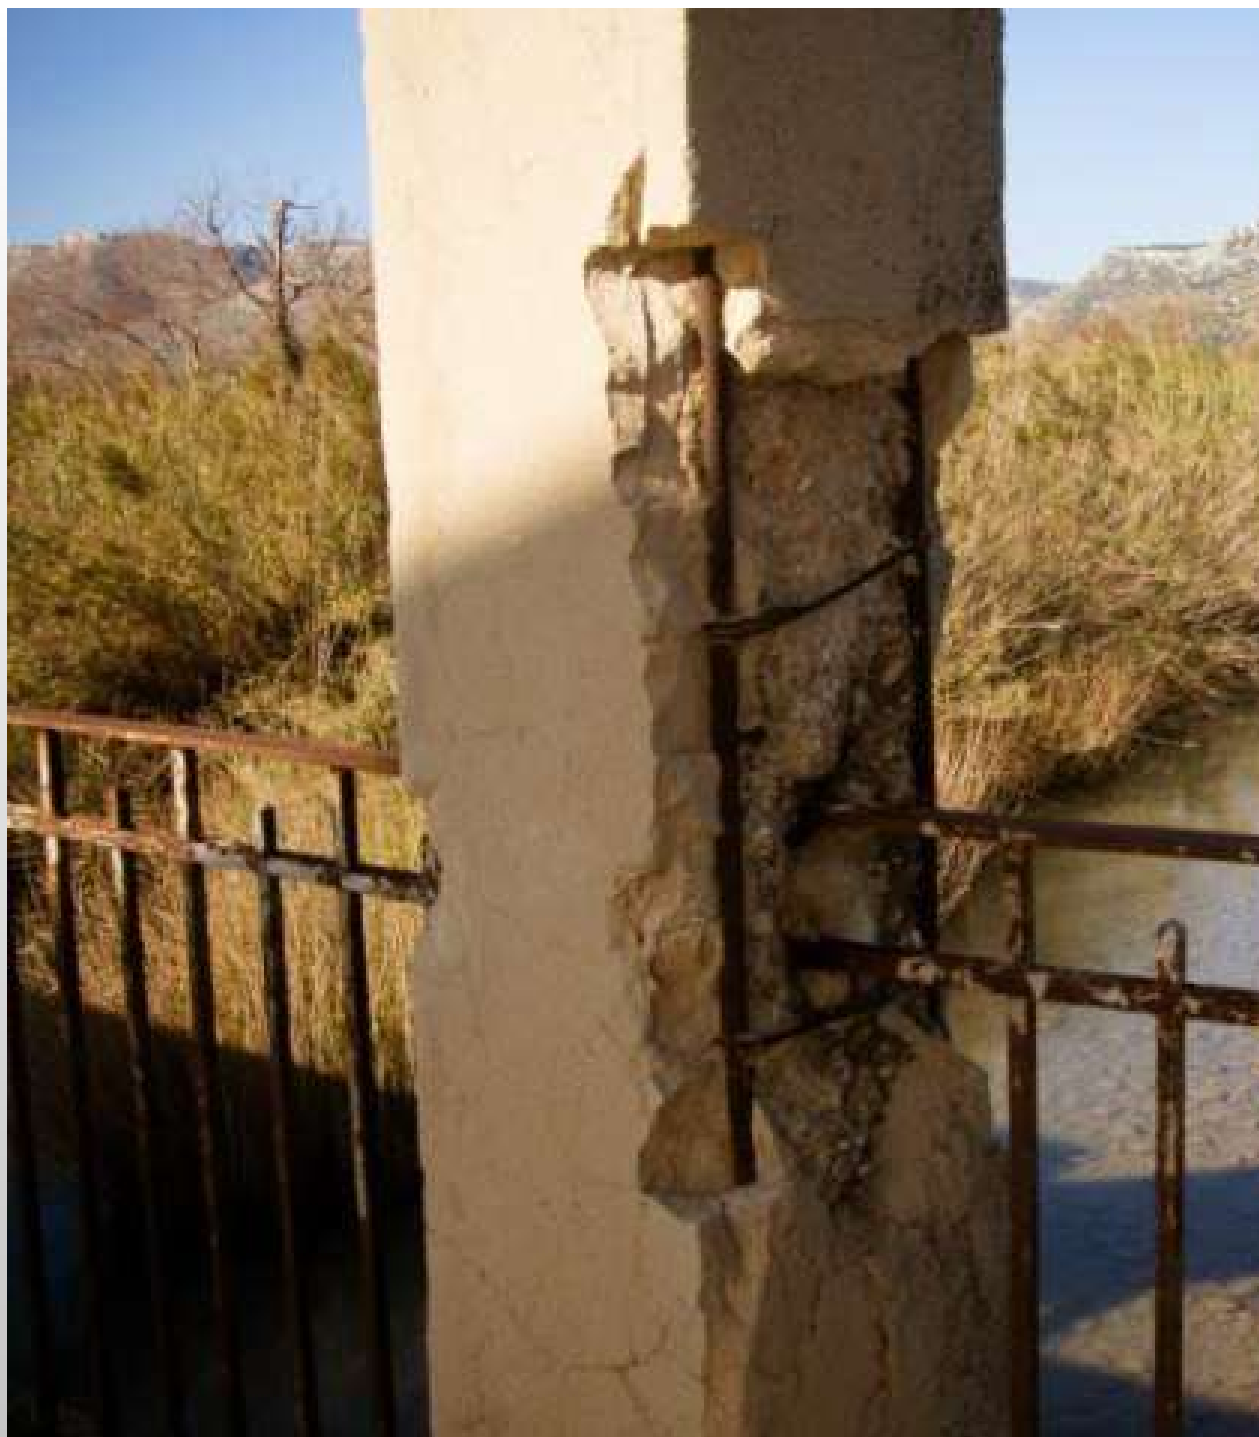
**Pendini – Espulsione del copriferro, corrosione dell'armatura longitudinale e trasversale dei pendini**
